Truck Transport Results / Progress on Rail Test

SNL-BAM Workshop
7 October 2014
Paul McConnell
SAND2014-18948 PE

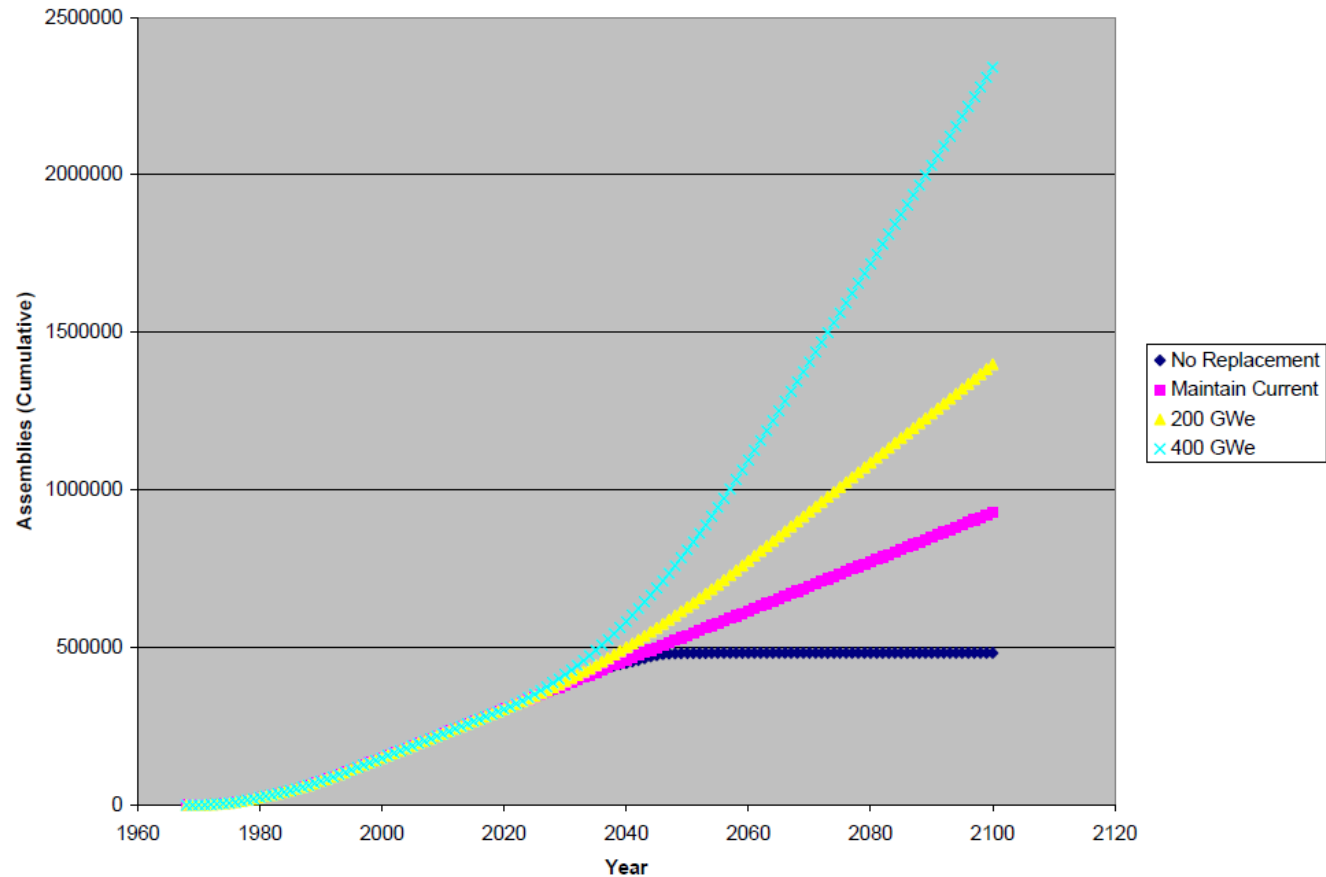
Figure 3-3 Cumulative UNF Assemblies Discharged for the No Replacement, Maintain Current, 200 GWe/yr, and 400 GWe/yr.

Lots of Assemblies to be Stored & Transported

Fuel Cycle Potential Waste Inventory for Disposition
July 2012

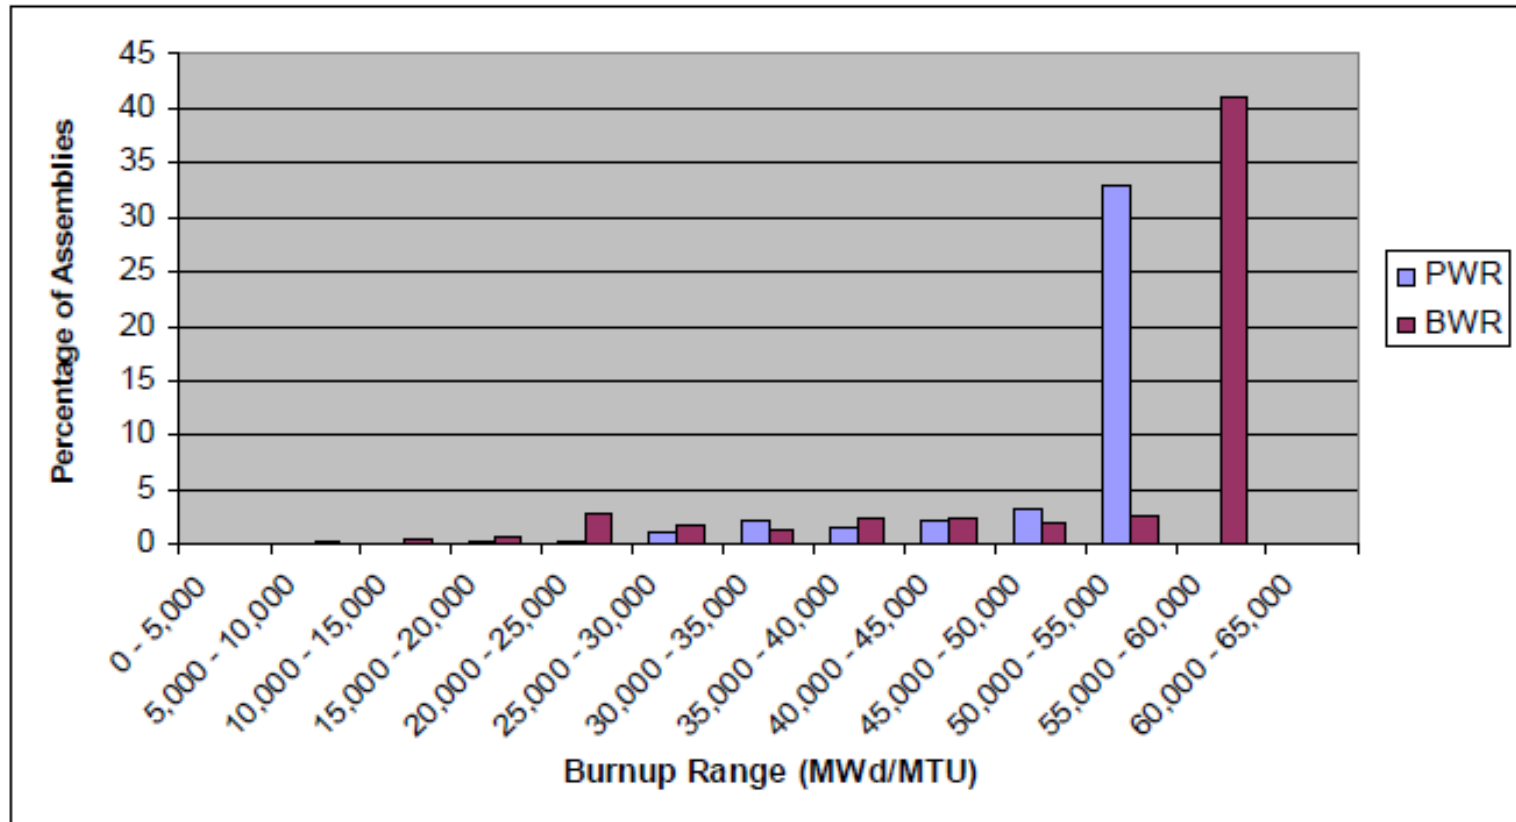
Figure 3-7 Percentage of Assemblies per Burn-up Range – Maintain Current Nuclear Generation Case

There Will Be Lots of High Burnup Assemblies

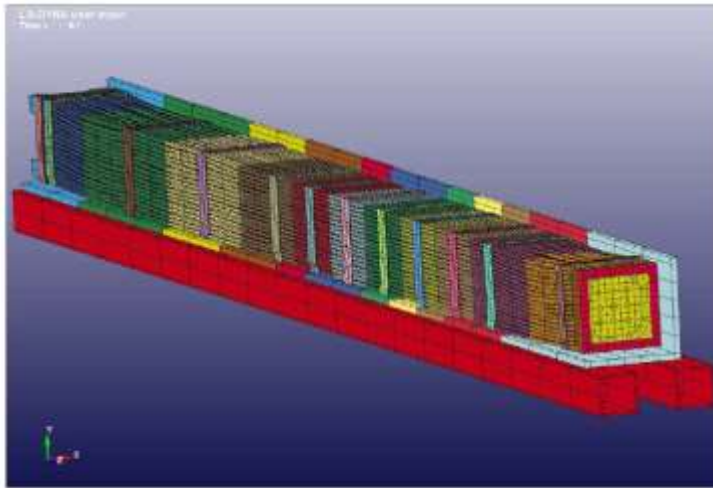
- The data from the assembly tests will be used to validate finite element models of fuel assemblies.
- The validated models can be used to predict the loads on fuel rods for other basket configurations and transport environments, particularly rail.

FUEL ASSEMBLY SHAKER TEST SIMULATION, Klymyshyn, et al., PNNL,
FCRD-UFD-2013-000168, May 2013

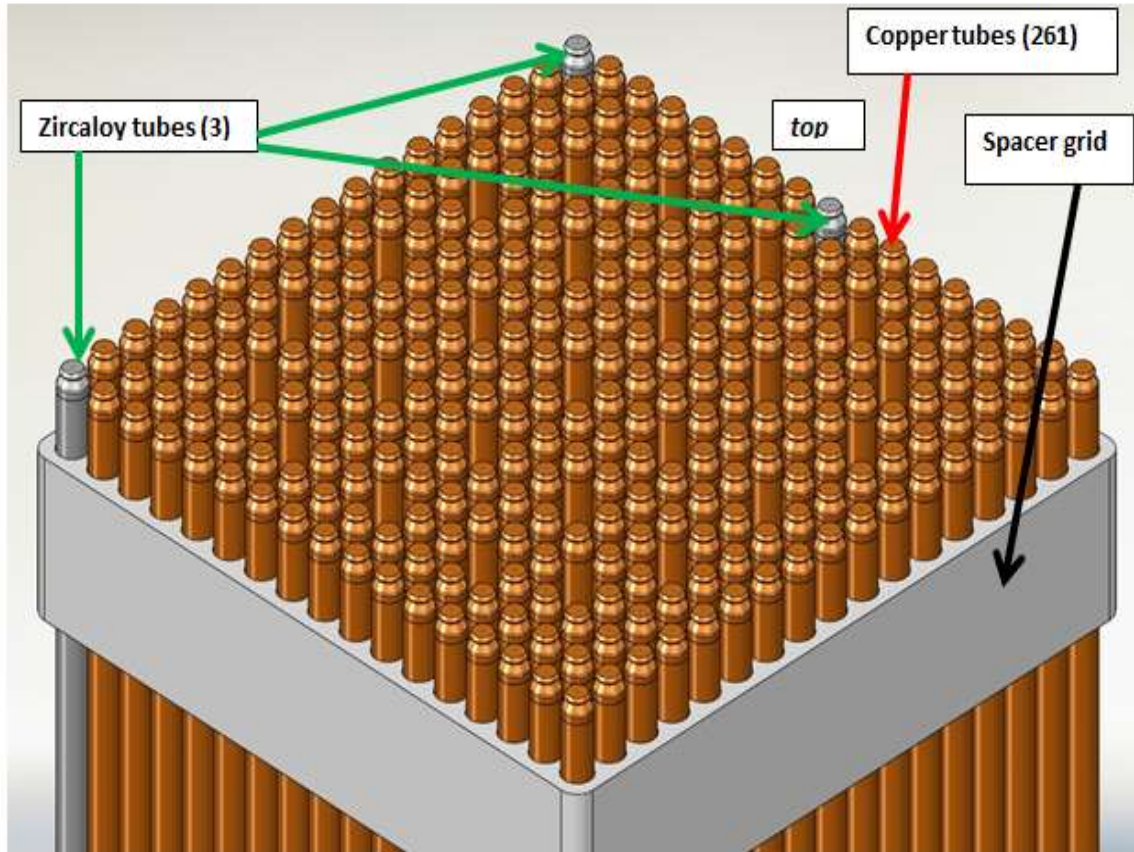
SNL Experimental 17x17 PWR Assembly

Only Zircaloy rods were instrumented with strain gauges and accelerometers

Isometric View of Fuel Rods
(Top Nozzle and Basket not shown)

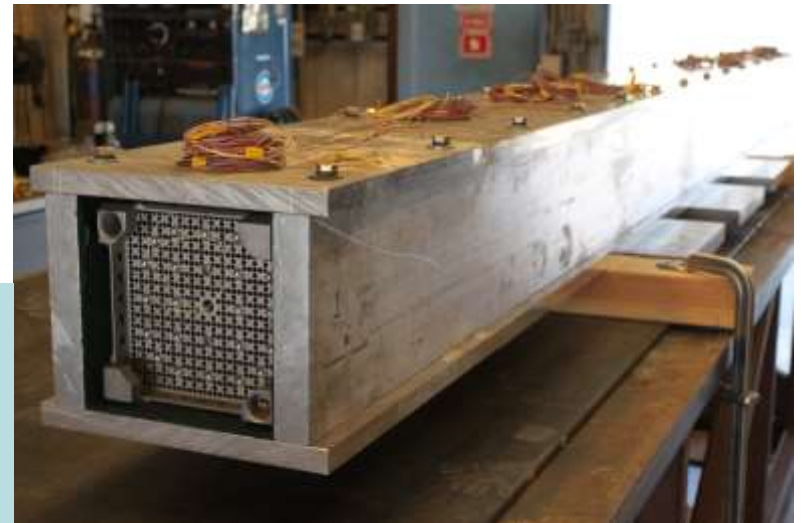
Basket/Assembly Test Unit

- The test unit included an assembly and a basket.
- The basket is based upon the geometry of the NAC-LWT truck cask PWR basket.
- The assembly was placed in a basket which was placed on 1) a shaker and subsequently 2) a truck trailer.
- The assembly had the same freedom of motion within the basket as it would have in an actual cask.

- 6061 Aluminum Basket
- Sides 1.5 inches thick
- Top/bottom 1 inch thick
- Length 161.5 inches
- Weight 837 pounds

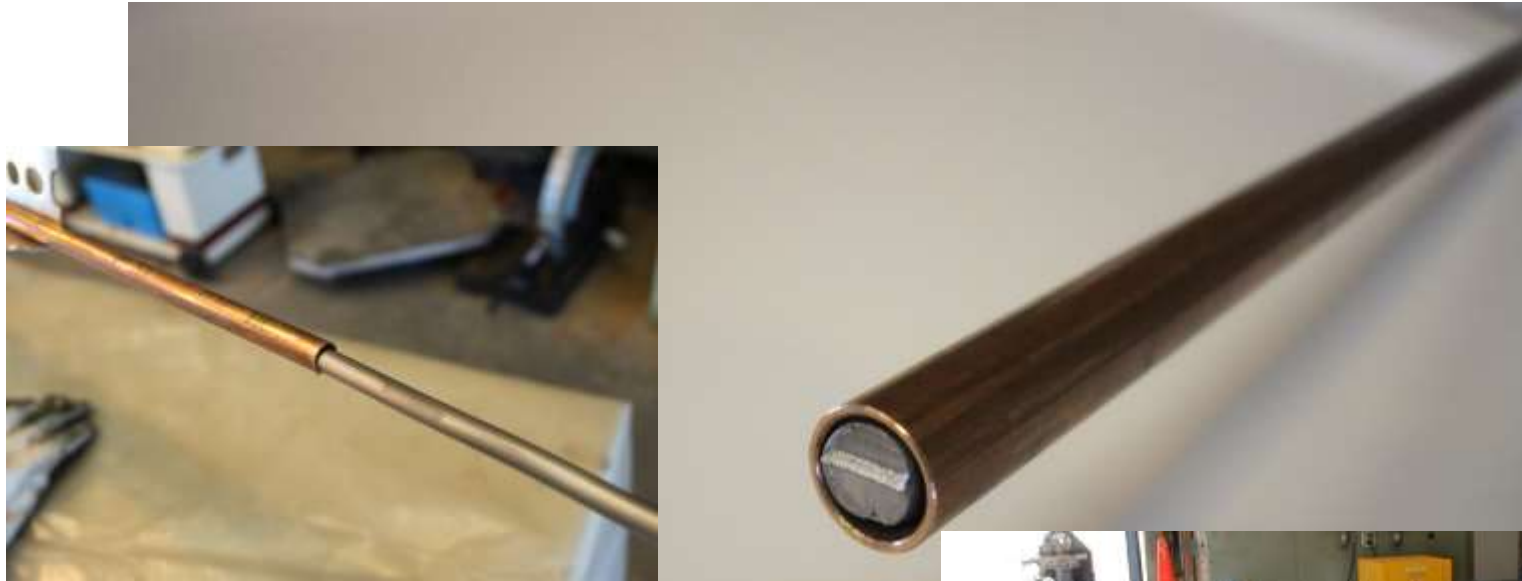
Lead Rod within Copper Tube to Simulate Mass of UO_2 (Zircaloy-4 tubes also contained Lead)

Initial Dimensions for Simulated Copper Fuel Rod Mock-up	
	Cu
OD (in.)	0.3750
ID (in.)	0.3120
Thickness (in.)	0.0315
Sample Length (in.)	24.0000
Clearance Between Cu & Pb	0.0300

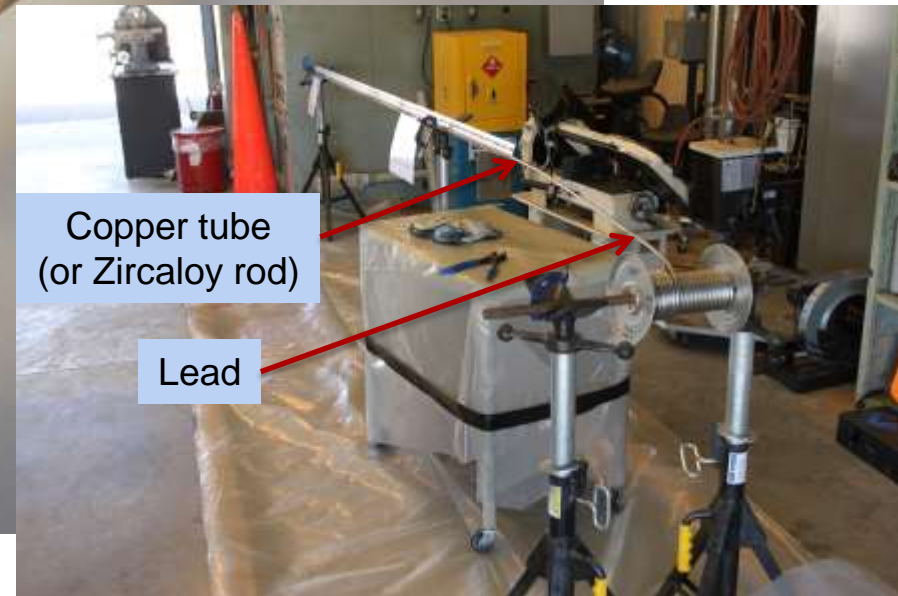
Uniaxial Accelerometer and Strain Gauge on Test Assembly

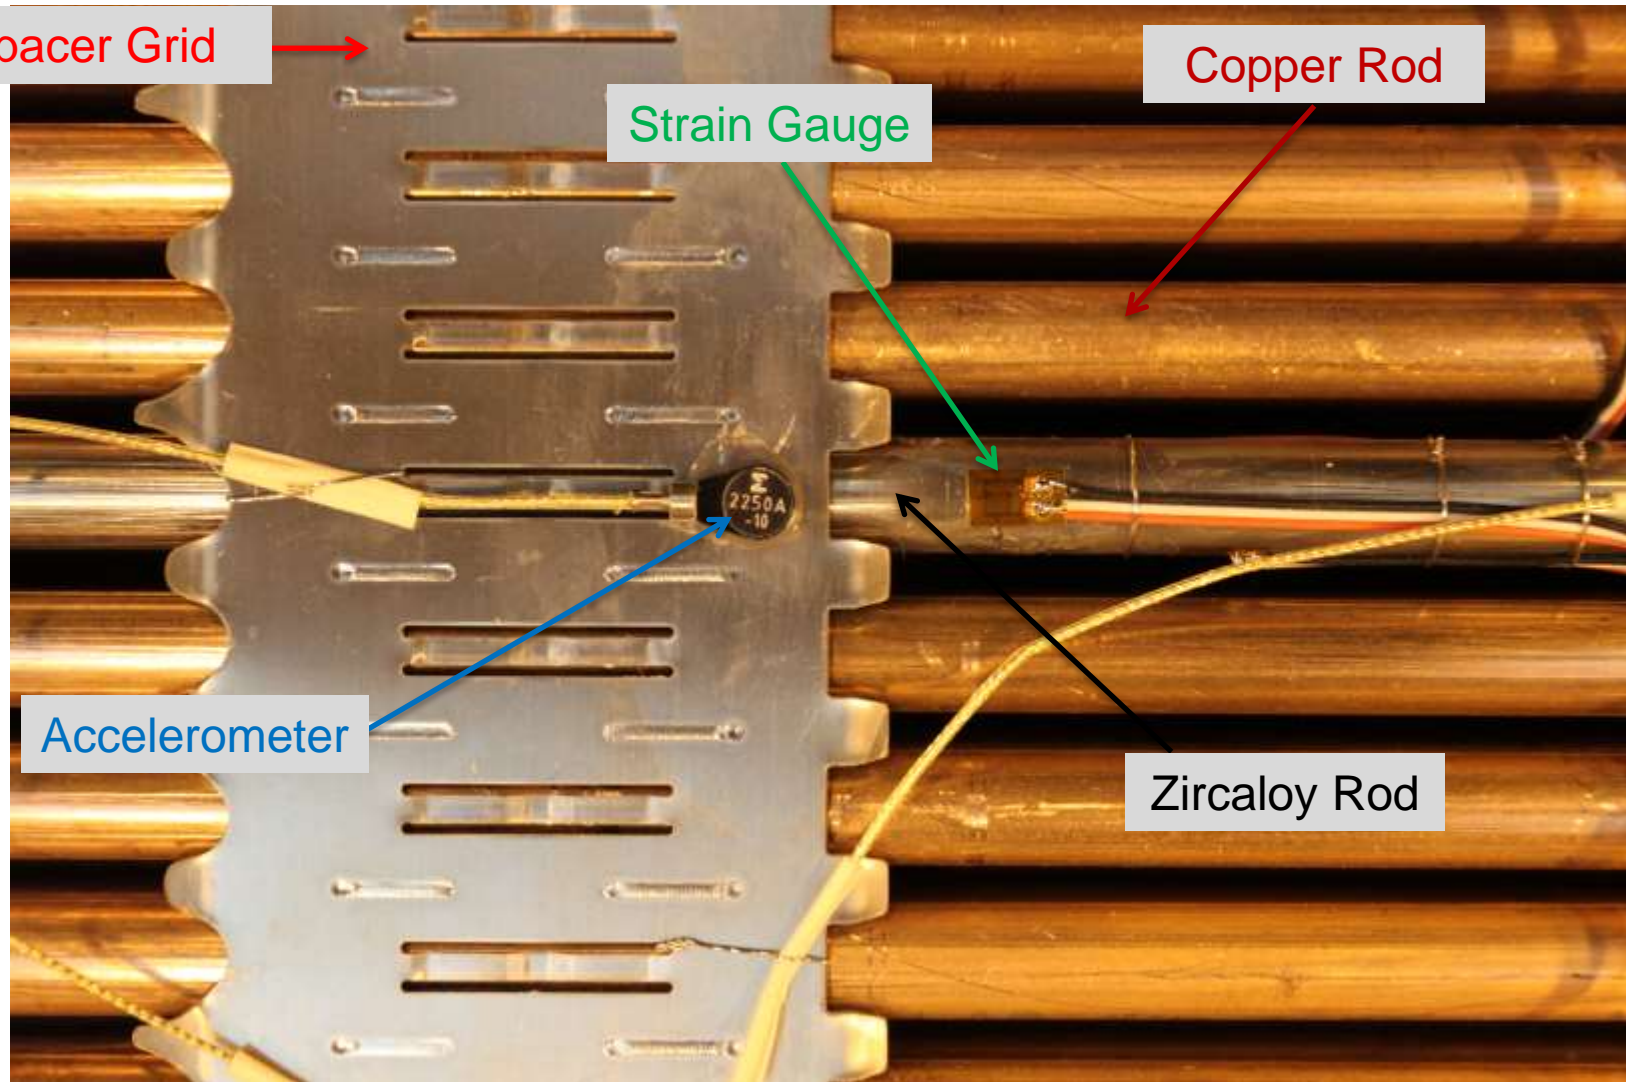
**Left: Accelerometers and Strain Gauge on Top-Center
Zircaloy Tube and Spacer Grid**

**Right: Assembly within Open Basket. Note the two Zircaloy-4 rods
with instrumentation attached**

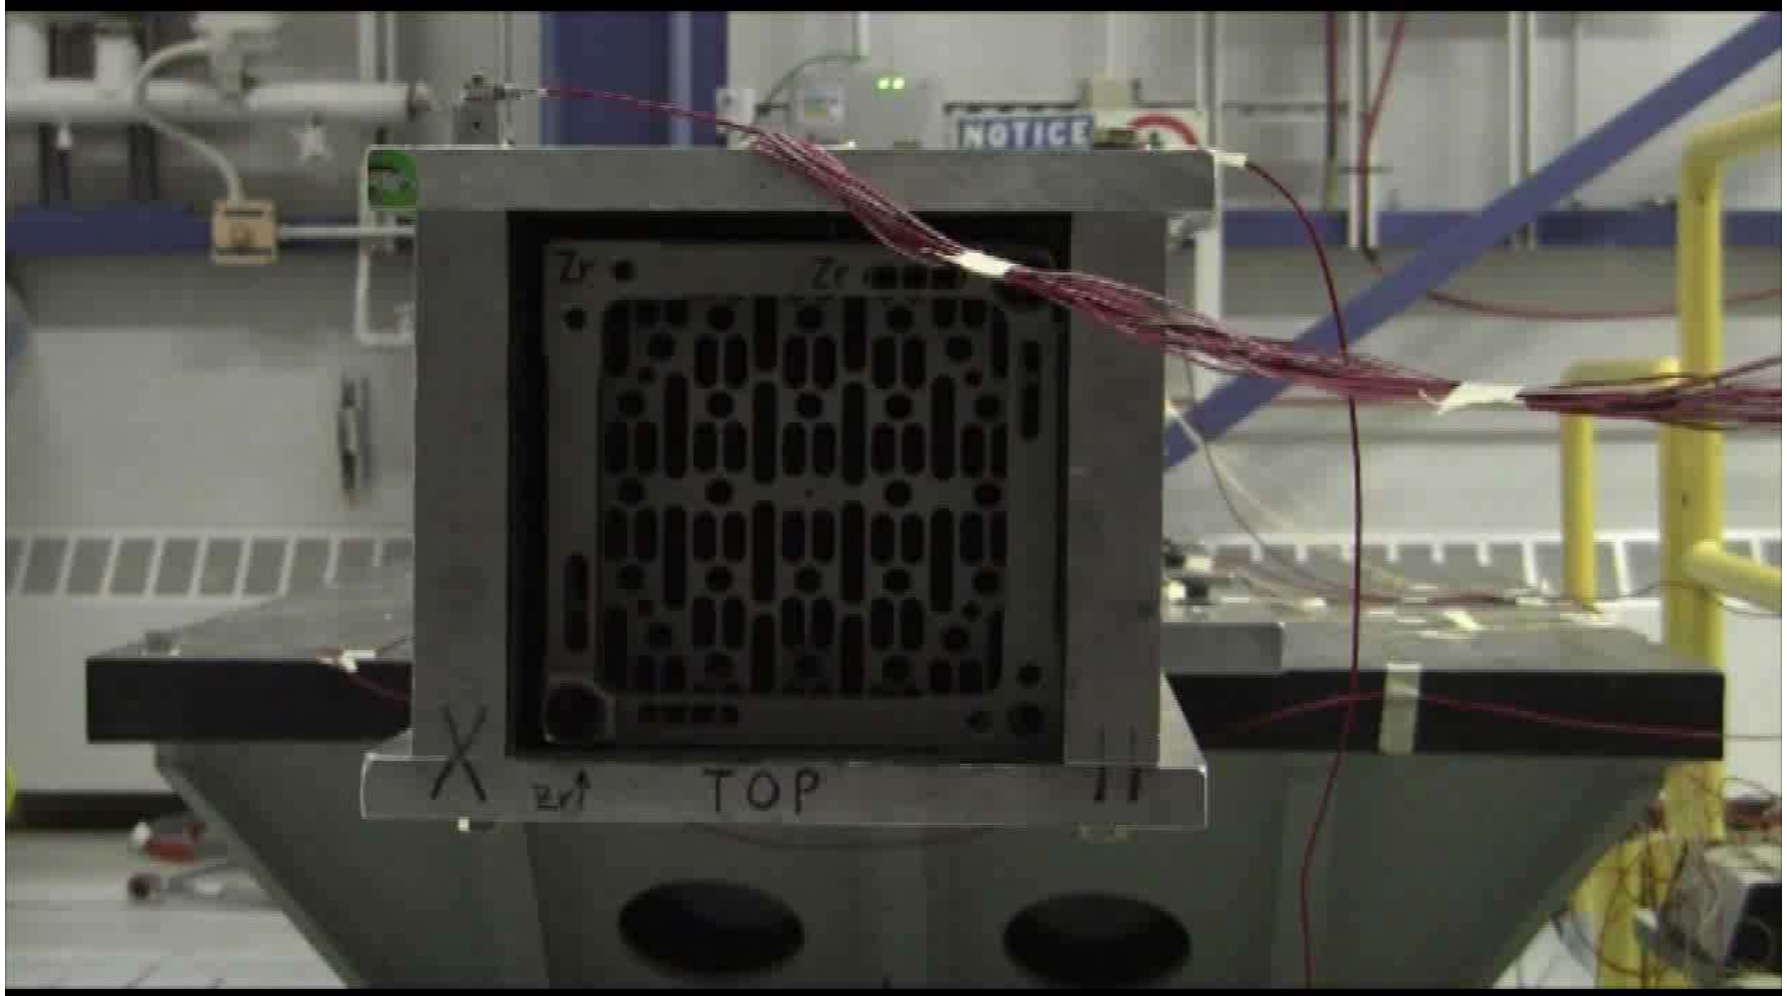
Maximum Micro-strains on Zircaloy Fuel Rods during Shaker Shock Test – *Strains are very low*

Maximum Strains on Zircaloy Fuel Rods, Shock Test #1			
Rod Location	Assembly Span	Position on Span	Maximum Strain (µin./in.)
Top-middle rod	Bottom-end	Adjacent to spacer grid	90
Top-middle rod	Bottom-end	Mid-span	131
Top-middle rod	Bottom-end	Adjacent to spacer grid	171
Top-middle rod	Mid-assembly	Adjacent to spacer grid	104
Top-middle rod	Mid-assembly	Mid-span	97
Top-middle rod	Top-end	Adjacent to spacer grid	127
Top-middle rod	Top-end	Mid-span	199
Top-middle rod	Top-end	Adjacent to spacer grid	70
Top-side rod	Bottom-end	Adjacent to spacer grid	54
Top-side rod	Bottom-end	Mid-span	107
Top-side rod	Top-end	Mid-span	117
Top-side rod	Top-end	Adjacent to spacer grid	113
Bottom-side rod	Bottom-end	Mid-span	62
Bottom-side rod	Bottom-end	Adjacent to spacer grid	121
Bottom-side rod	Mid-assembly	Adjacent to spacer grid	110
Bottom-side rod	Mid-assembly	Mid-span	115
Average of All Strain Gages			112
Average Top-middle Rod			124

Average Top-side Rod			98
Average Bottom-side Rod			102
Average Bottom-end Span			105
Average Mid-assembly Span			107
Average Top-end Span			125
Average Mid span			118
Average Adjacent to Spacer Grid			107

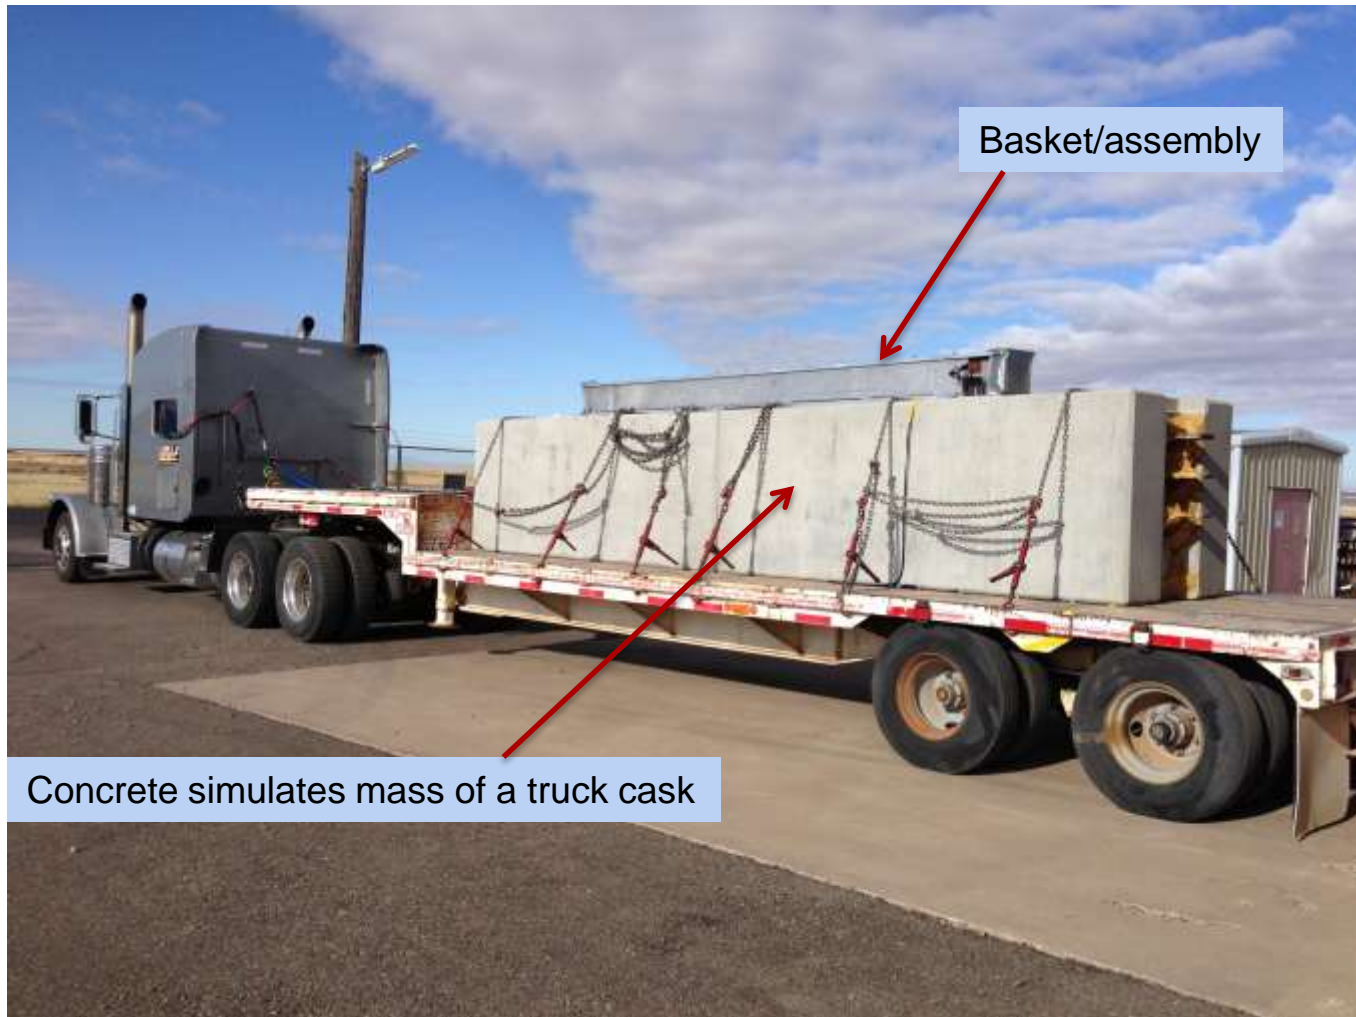
Test Unit on Concrete Blocks on Trailer

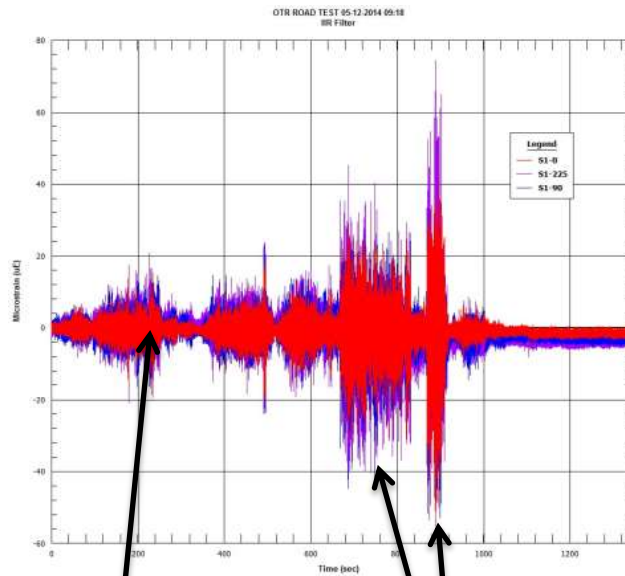
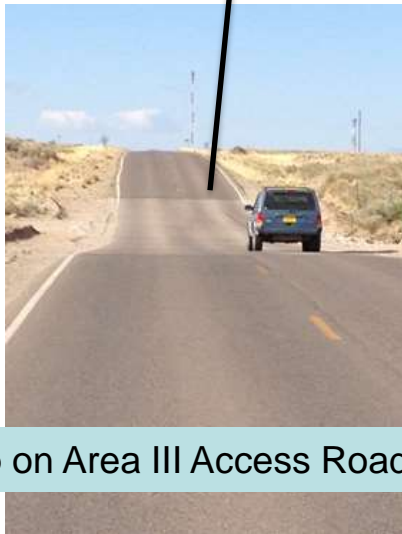
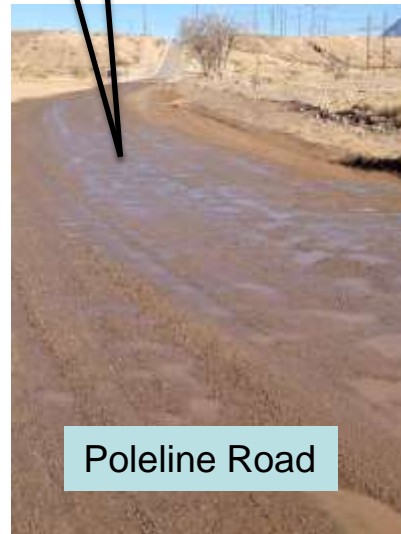
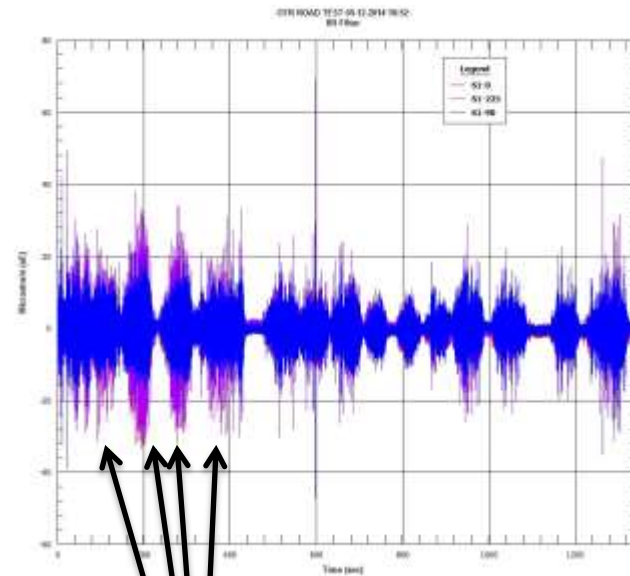
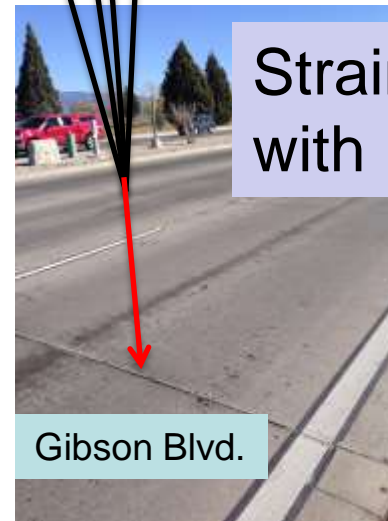
Strains measured on instrumented rod

dip on Area III Access Road

Poleline Road

Gibson Blvd.

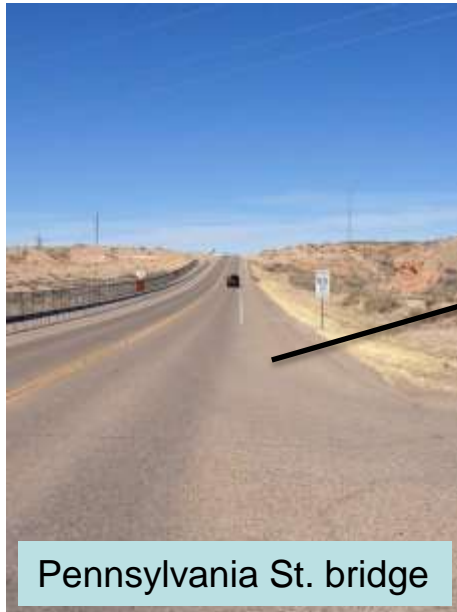
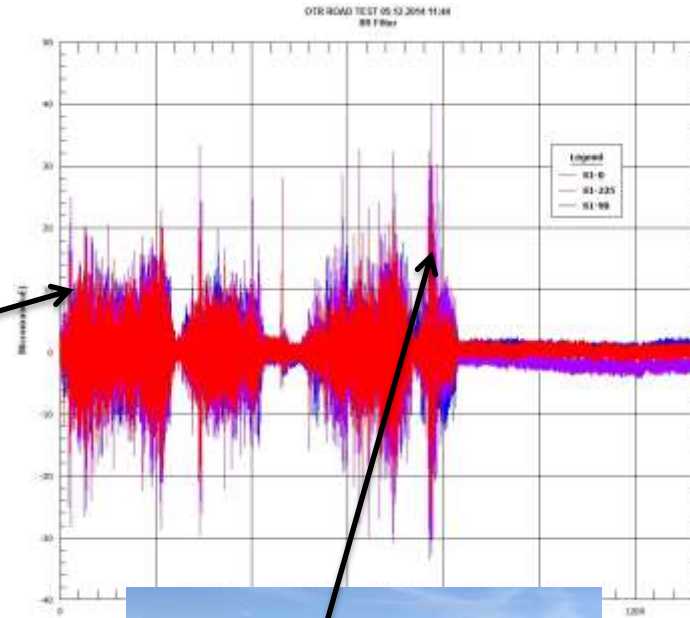
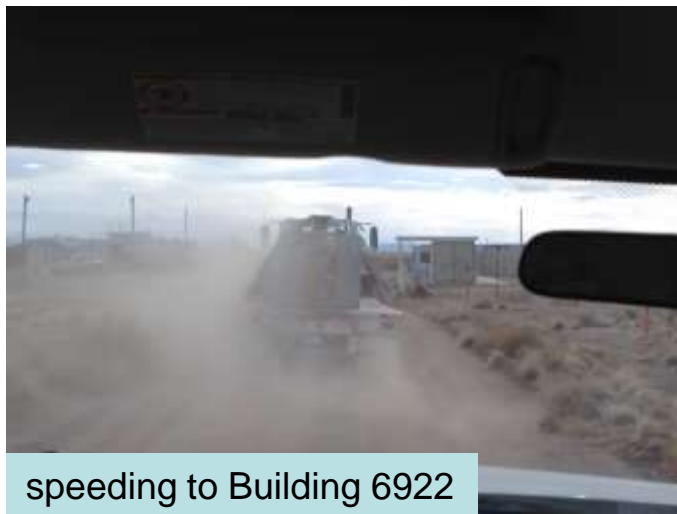
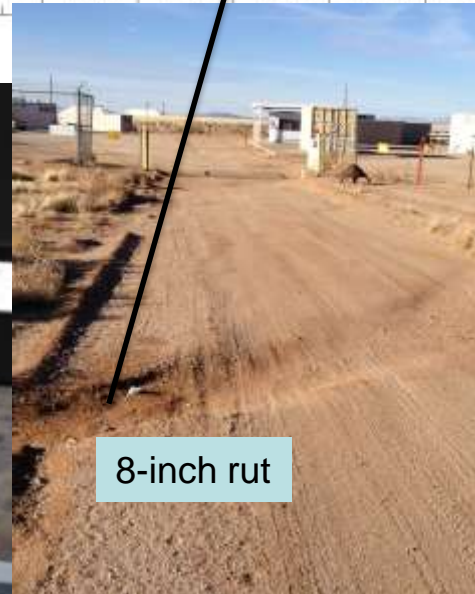
Strains correlated with road conditions

Strains correlated to road surfaces

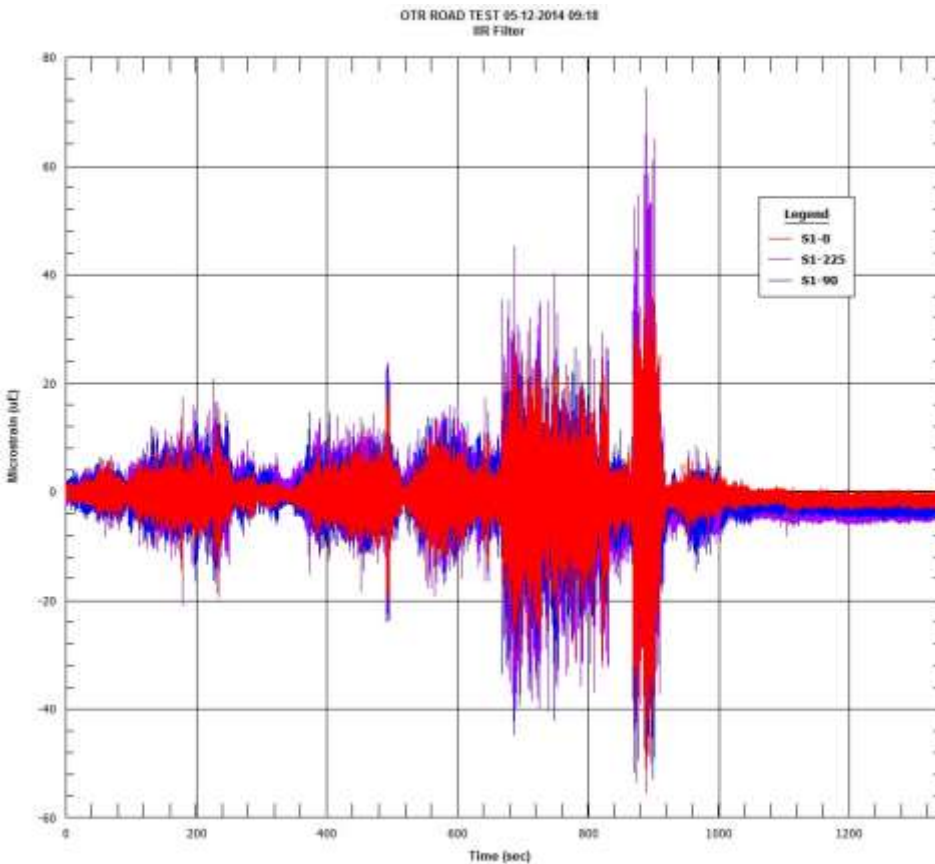
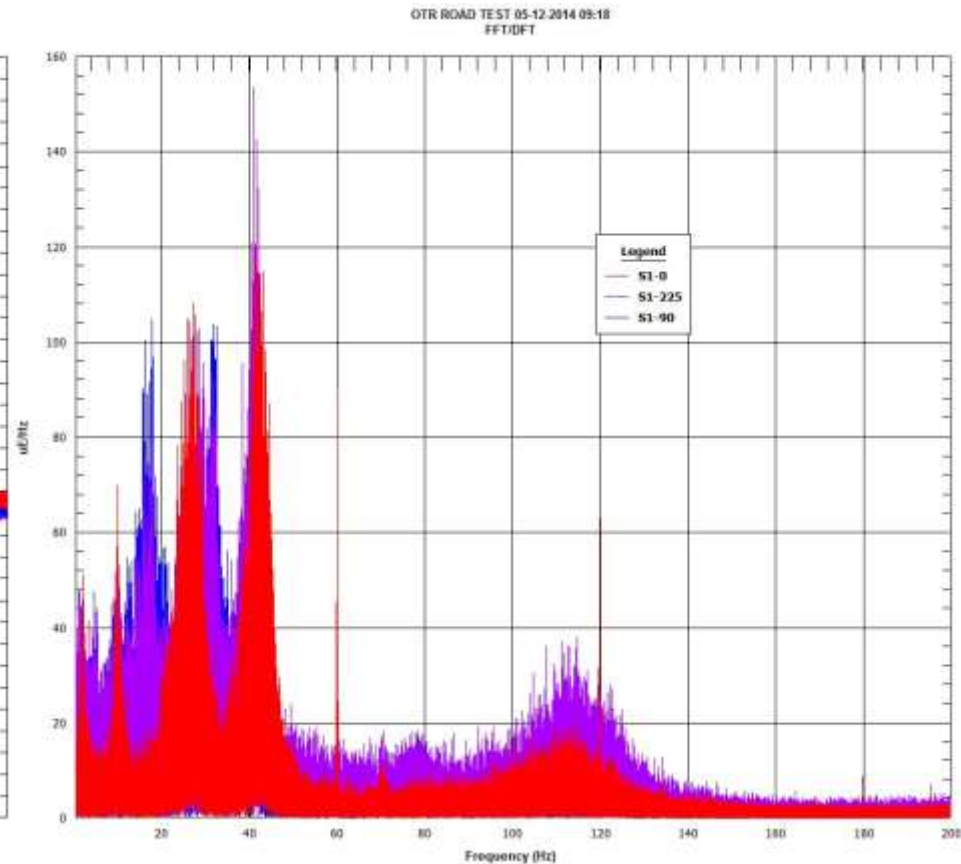
Rod Strains and FFT

maximum strains occurred at low Hz

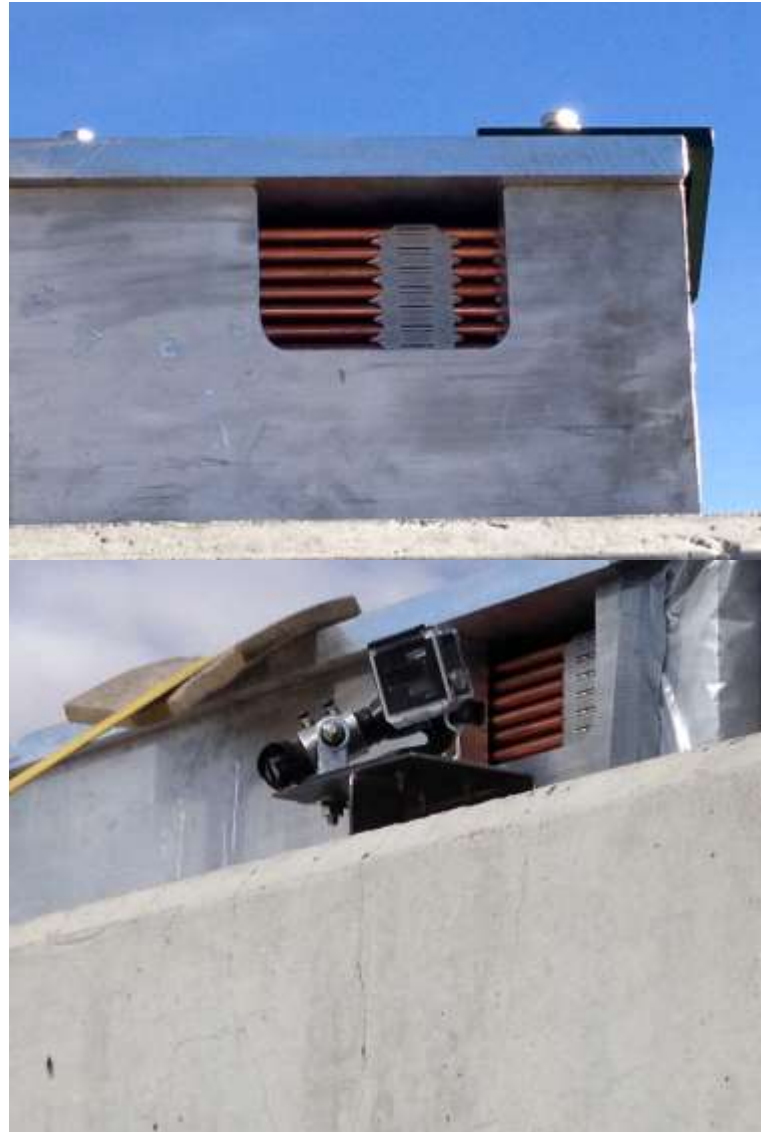
Side Basket Showing Cutout for Filming Assembly during Truck Test

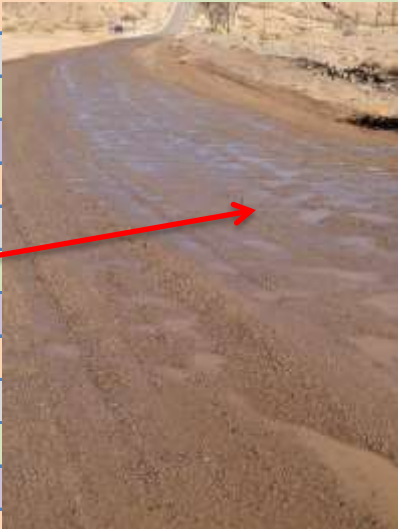
Maximum Strains Measured during Truck Test

similar to shaker results

Strain Gauge	Location on Assembly	Maximum Micro-strain Absolute Value ($\mu\text{in./in.}$)	Road Segment
S1 - 0°	Adjacent to first spacer grid, Span 10	55

S1 - 90°		53	
S1 - 225°		74	
S2 - 0°	Mid-span, Span 10	94	
S2 - 90°		99	
S2 - 225°		86	
S3 - 0°	Adjacent to first spacer grid, Span 5	143	
S3 - 90°		84	
S3 - 225°		108	
S4 - 0°	Mid-span, Span 5	69	
S4 - 90°		101	
S4 - 225°		93	
Average 0°		90	1
Average 90°		83	
Average 225°		90

All maximum strains during road Segment #1 at 872.4 – 902.3 seconds into the trip. This corresponds to travel on Poleline Road (dirt).

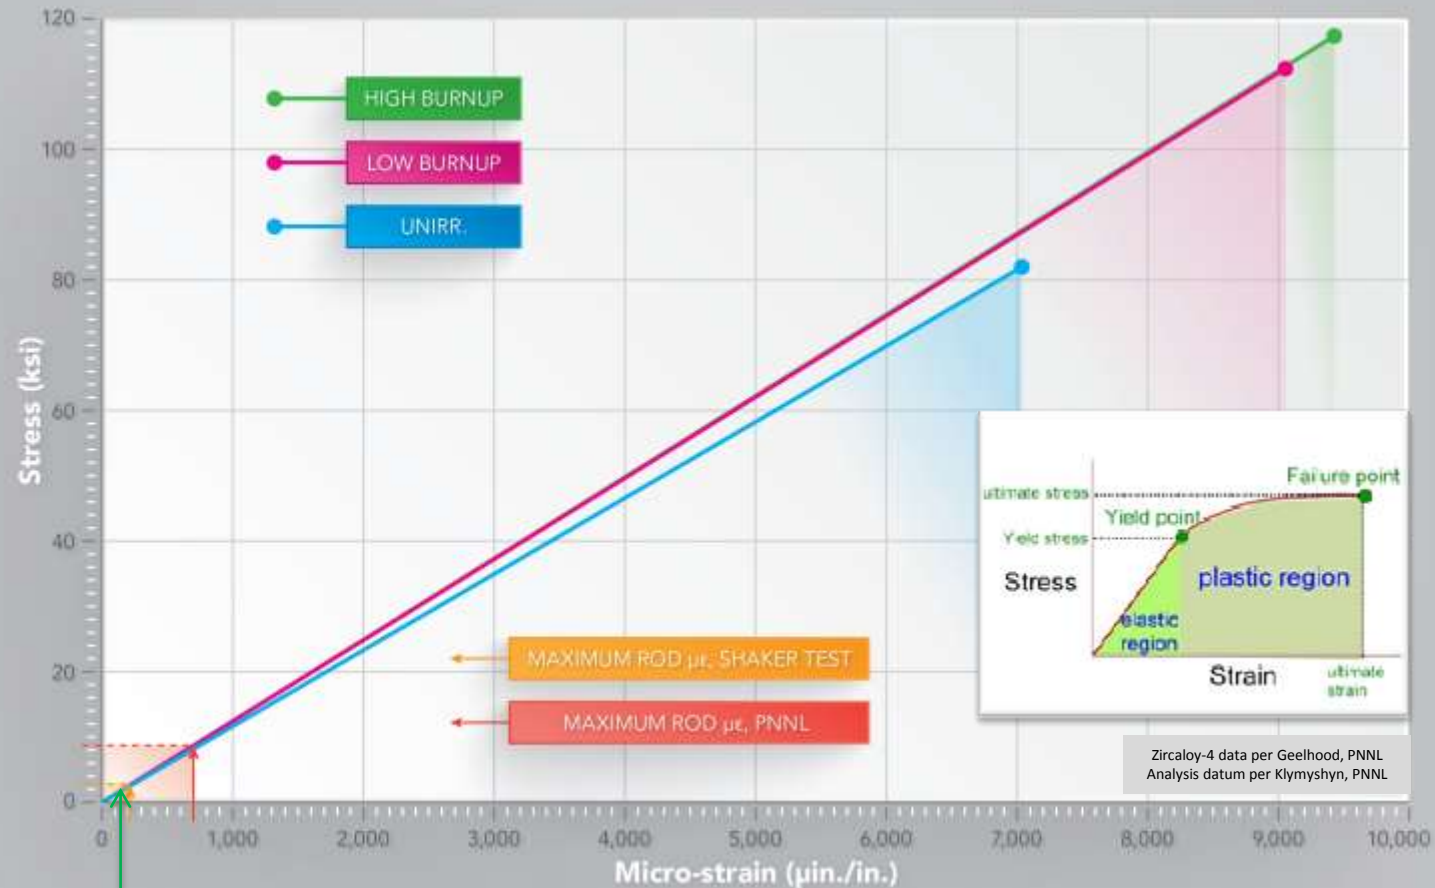
Measured Strains are Very Low Relative to the Elastic Limit of Zircaloy-4

MAXIMUM STRAIN TRUCK TEST $\approx 143 \mu\text{in./in.}$

Irradiated rods would experience lower strains during truck test than unirradiated tube

This implies that for a given applied moment, strains on an irradiated rod would be approximately 0.3 ($1/3.27$) of those on an unirradiated Zircaloy-4 tube.

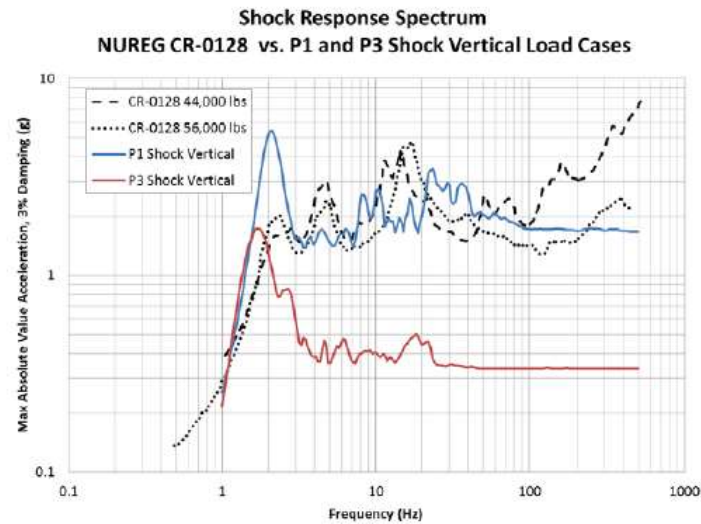
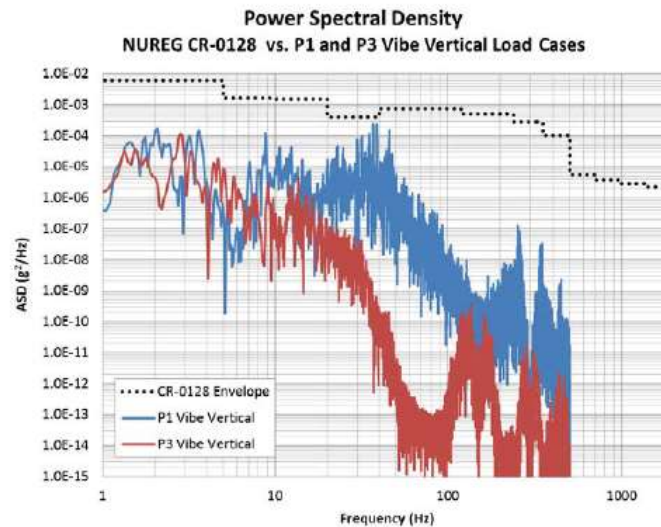
Figure 5.15 Comparison of the P1 and P3 Load Cases with the NUREG/CR-0128 Shock and Vibration Load Environments

(a) Shock

Rail loadings less severe
 than truck loads

(b) Vibration

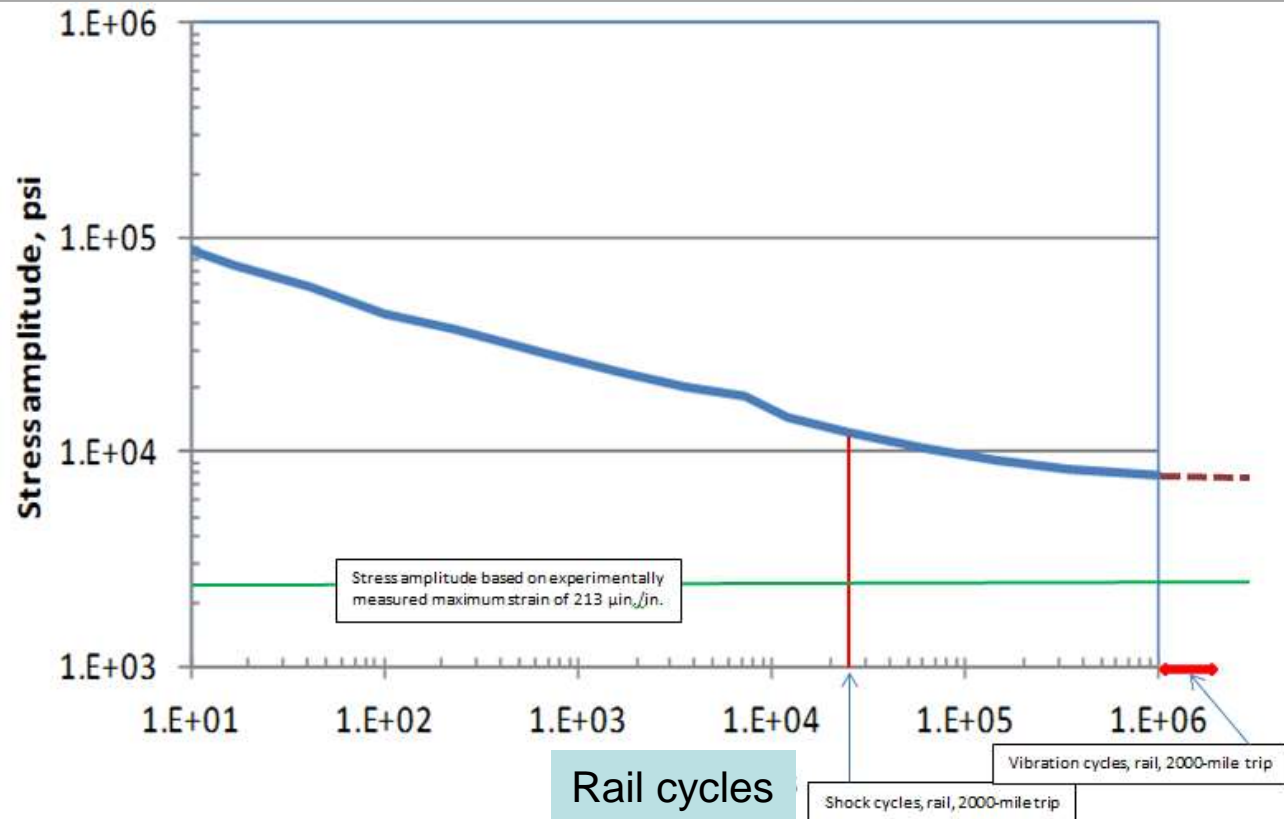
Fracture Mechanics & Fatigue Assessments Based Upon Experimentally-Measured Strains

Crack depth/Zircaloy wall thickness	Applied stress intensity at crack tip, (MPa-√m)	Lower bound Zircaloy-4 fracture toughness, (MPa-√m)
0.10	0.3	20 - 30
0.25	0.4	
0.50	0.6
